# POLICE DEPARTMENT RENOVATION OR REPLACEMENT ANALYSIS

TOWN OF NORTH SMITHFIELD, RHODE ISLAND

SEPTEMBER 2021

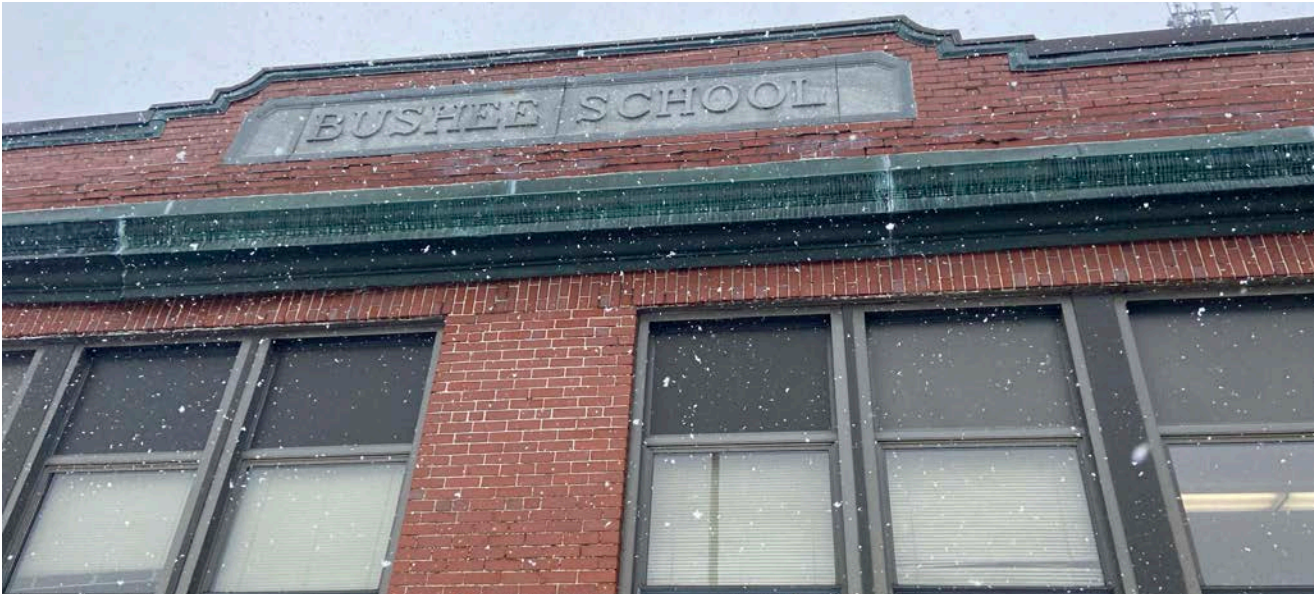
Exterior walls are predominantly brick masonry, with some copper detailing and precast concrete elements. The brick masonry, which comprises 90% of the exterior walls, is failing. There is substantial cracking along many masonry joints, suggesting significant water damage within the load bearing masonry construction. These joints are deteriorating at a particularly high rate on the front façade, as well as the rear of the building. It is our opinion, that many of the header bricks, which are courses tying the three wythes of brick together, are failing, causing the front wythe of brick to detach. As a result, the front wall has significant bowing, jeopardizing the stability of the wall. This presents clear evidence of significant water infiltration over time, likely from the roof and parapet. The bowing of the wall has also cause the copper detailing to crack and pull away from the building. This has allowed for animals to nest and access the inner parts of this construction. This structural damage plus the weight of the precast elements presents an immediate safety concern at this location, and a significant risk of collapse. The precast elements are in fair condition. Exposed foundation walls are in fair condition but at locations where exterior ramps were added, moisture is infiltrating at these joints causing mold growth and deterioration on the interior. Overall, the exterior walls are an immediate concern and require significant reconstruction.

Deteriorating Front Facade

The entire roof and parapet need to be rebuilt. The thermal envelope is not compliant with current energy efficiency standards. The exterior wall and roof construction is contributing to water damage, thermal bridging, and moisture issues. The façade will continue to deteriorate and at the very least will exacerbate this problem. At worst, the front façade will collapse.

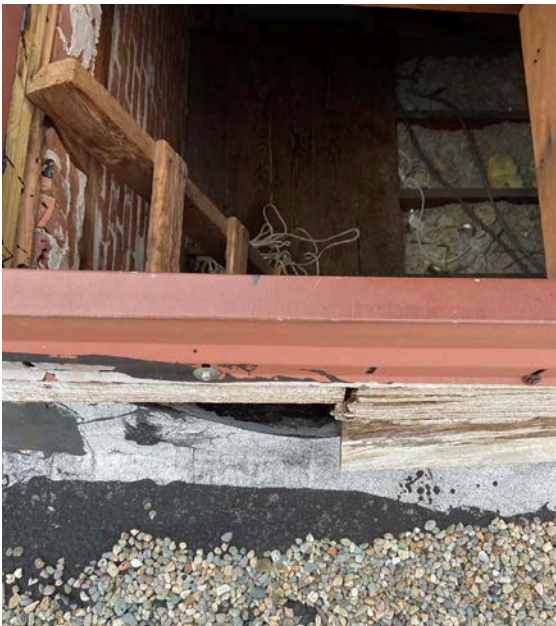
Gaps at Roof Hatch

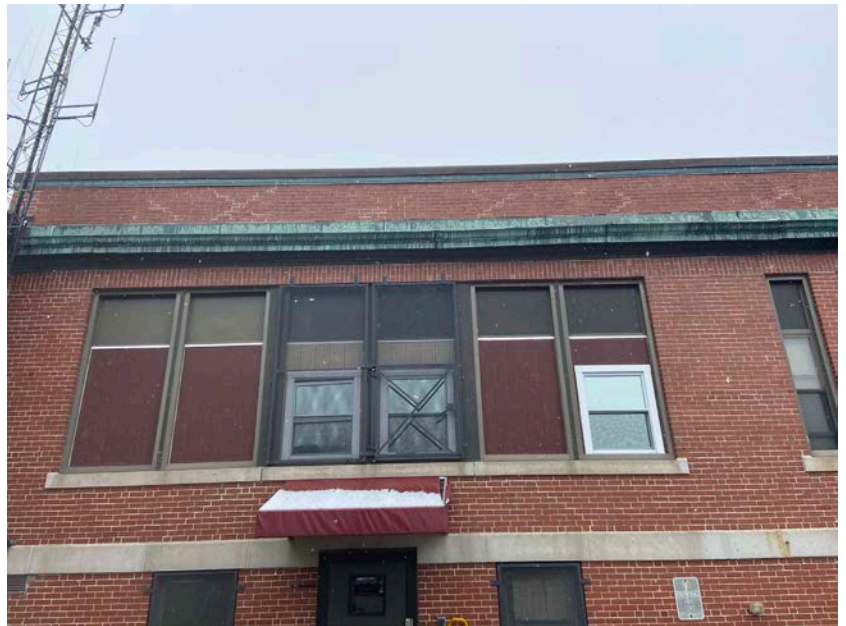
Vinyl Windows and Untethered Antenna

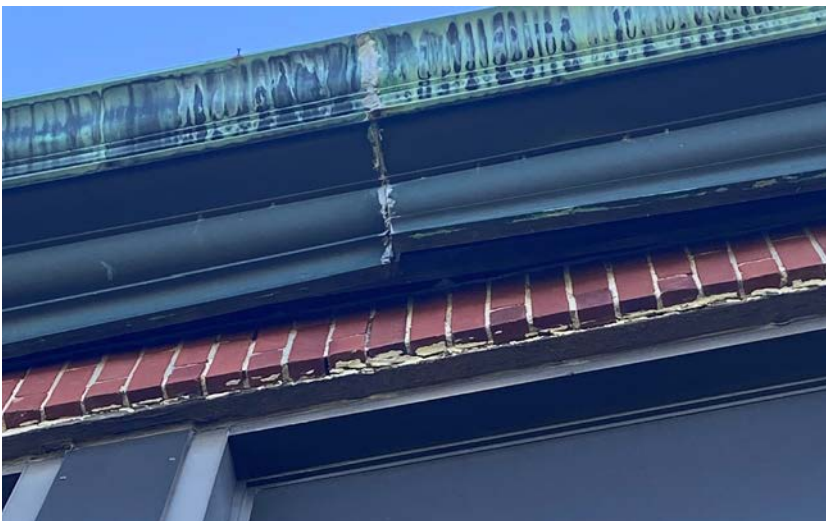
Copper Parapet Displaced by Masonry Failure

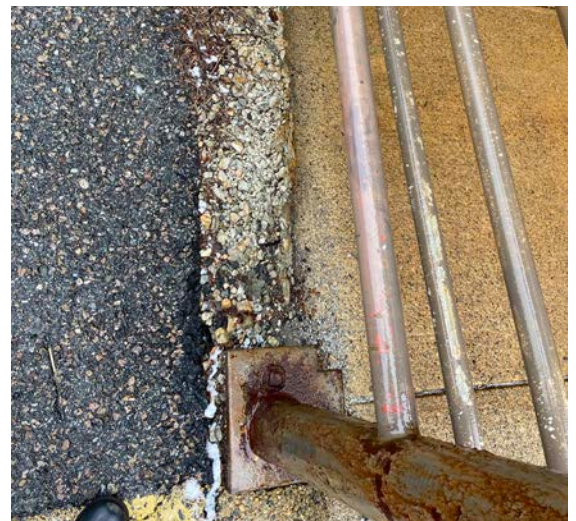
The exterior ramps to the lower-level need maintenance and/or restoration as there is substantial visible decay of the concrete and metal railings. Stormwater is not being drained properly from paved surfaces and is infiltrating the building causing damage on the interior of the masonry walls. Debris, loose equipment, and trash bins are also located along the exterior wall in the rear of the building, directly adjacent to the detention area entrance, posing safety and security risks to officers bringing a detainee into the facility.

Rust and Deterioration at Ramps

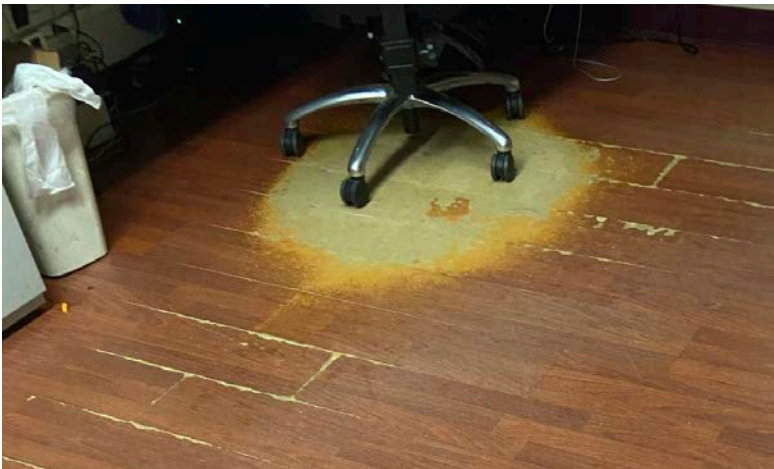
Floor Deterioration in Dispatch

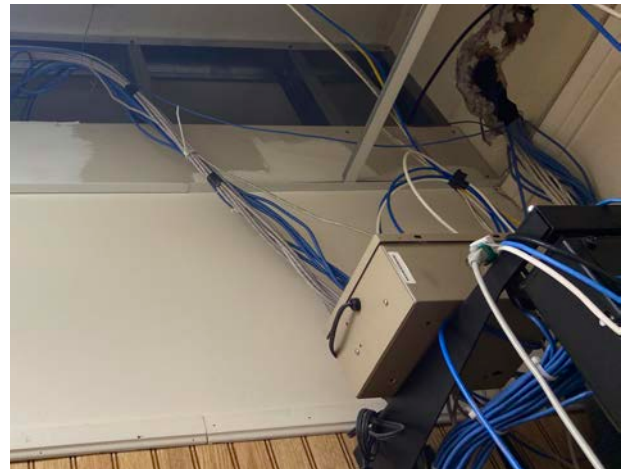
Non-compliant Wiring

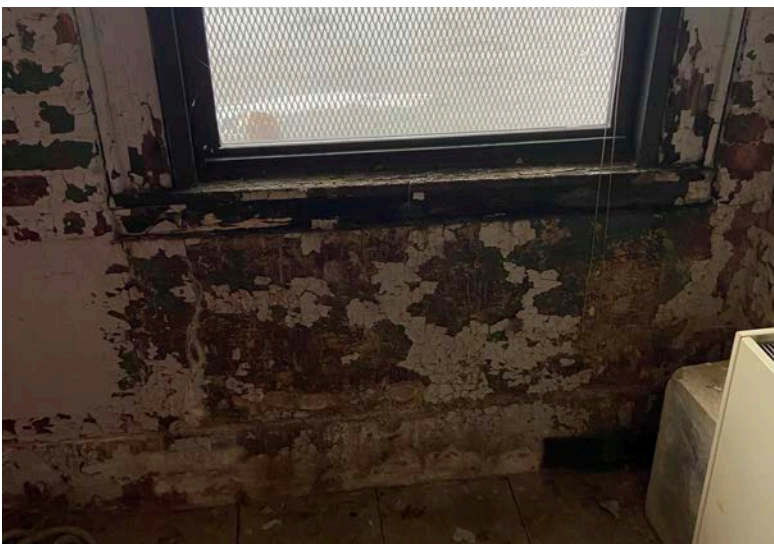
Mold and Moisture Damage

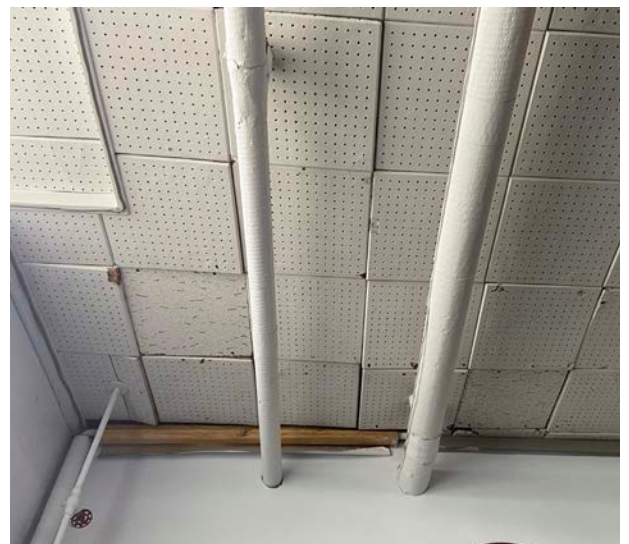
Wood Fiber Ceiling Tile Damage

Water infiltration is evidenced by the staining on ceiling tiles throughout the facility and by the peeling paint found on exterior walls. The water damage is worse at the exterior walls, but also extends deeper into the building. The fitness room is finished with a 9x9 floor tile and assumed to contain asbestos. VCT flooring that was installed over the original wood floor is cracking as the wood expands and contracts. The rolling chairs in dispatch, a space occupied 24 hours 7 days a week, have worn the top layer off the engineered flooring. Wood fiber ceiling materials located in the fitness room are combustible and have deteriorated over time. The warping of these tiles suggests exposure to humidity and moisture. All the finishes feel tired, are damaged, and could use an update.

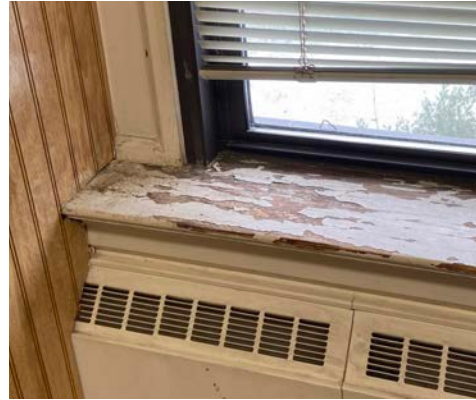
Windows are single pane, and the original aluminum frames are in disrepair. The window sills are wood, and the paint is original to the vintage; therefore presumed to contain hazardous materials. Rusting is evident at the lintels and should be scraped and painted. At dispatch, a large opening has been infilled with smaller vinyl windows that do not seem to be professionally installed. All windows should be replaced entirely. The public exterior entrances are the original wood doors with a glass clerestory and are in good condition. The exterior doors on the rear façade are metal and also in good condition, however they are not full height doors and are not code-compliant. The ramp just inside the staff entry door is also not ADA compliant. There are mechanical louvers on the exterior walls near grade which appear to be in good condition.

Original Windows and Sills

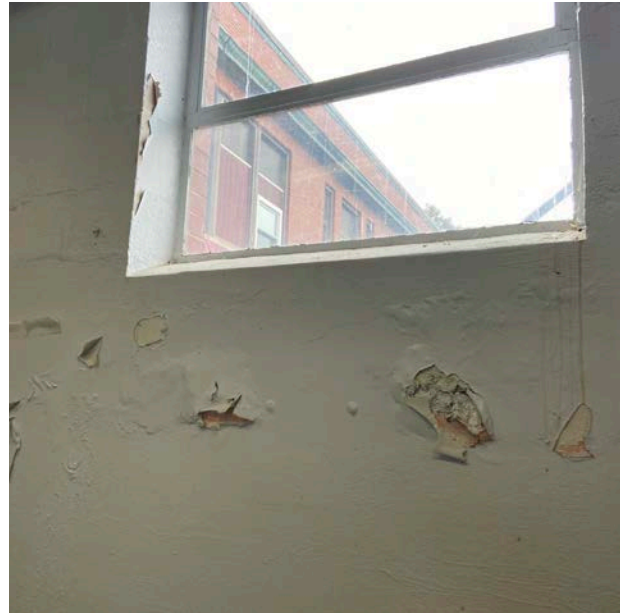
Water Damage at Exterior Wall

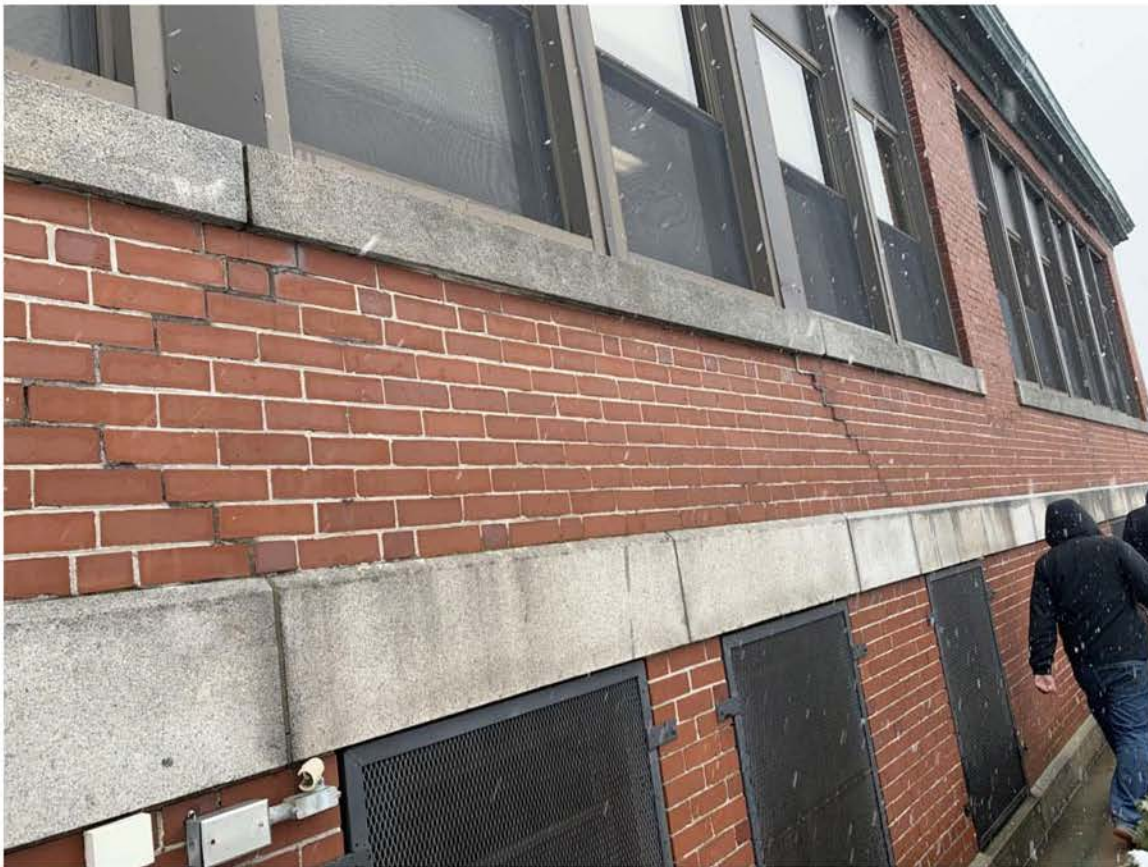
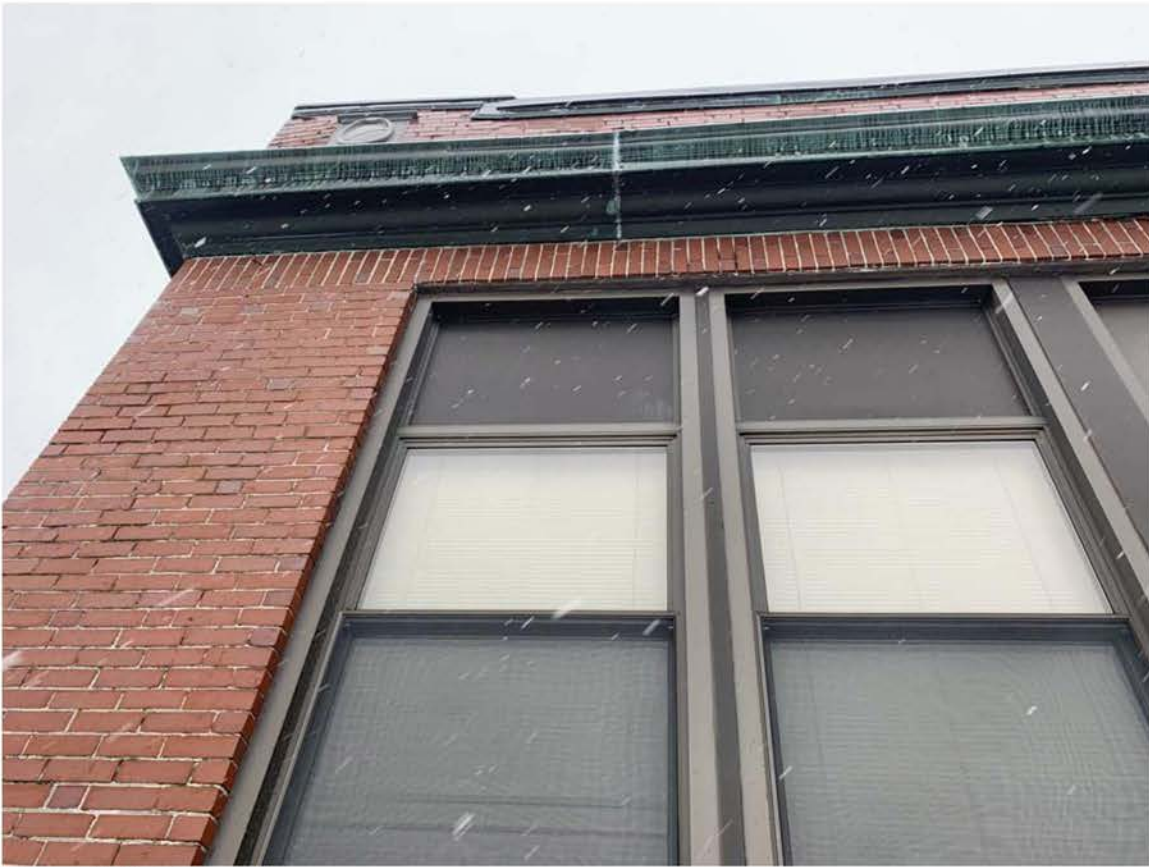
3. The front masonry wall (full length) is in complete disrepair, the entire wall needs to be rebuilt. See "Front Wall" Photos #4 & #5.
4. Masonry repairs/waterproofing/repointing is required at multiple locations. See "Masonry Repairs" Photo #6 for an example of the repairs required.

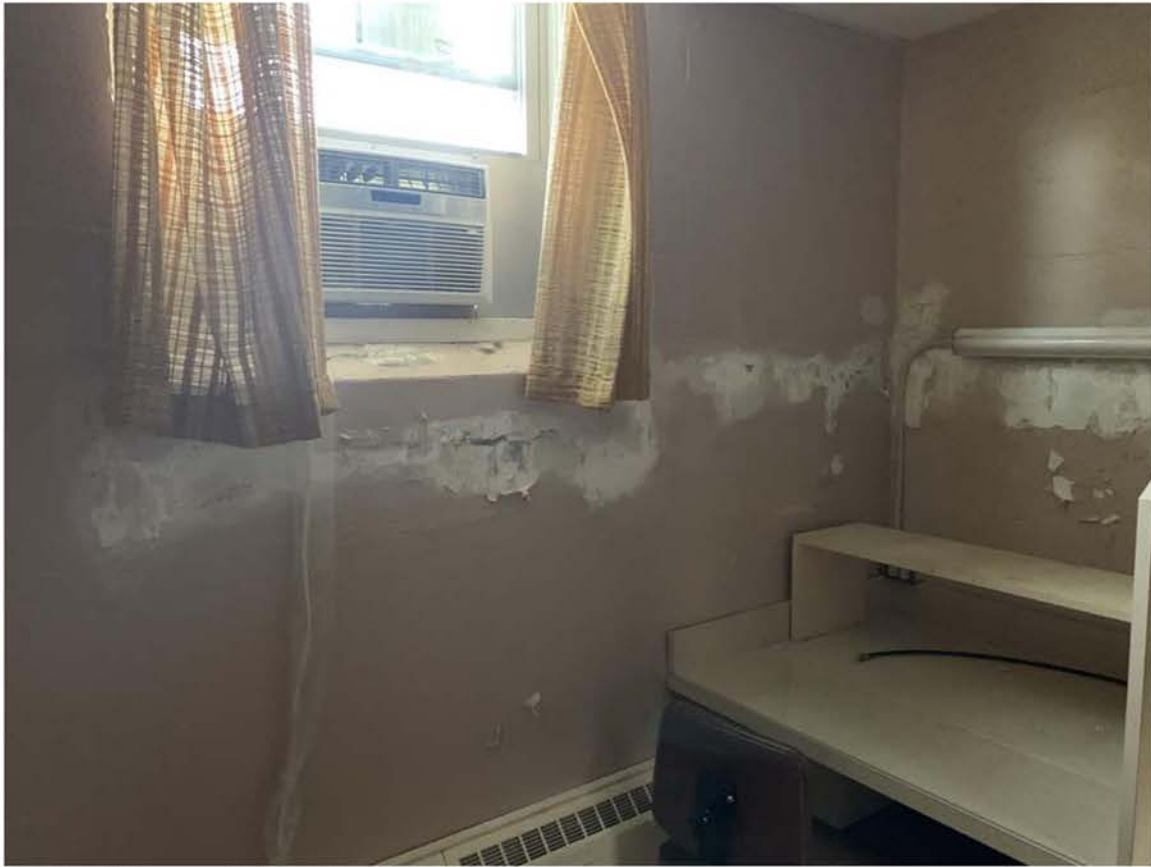
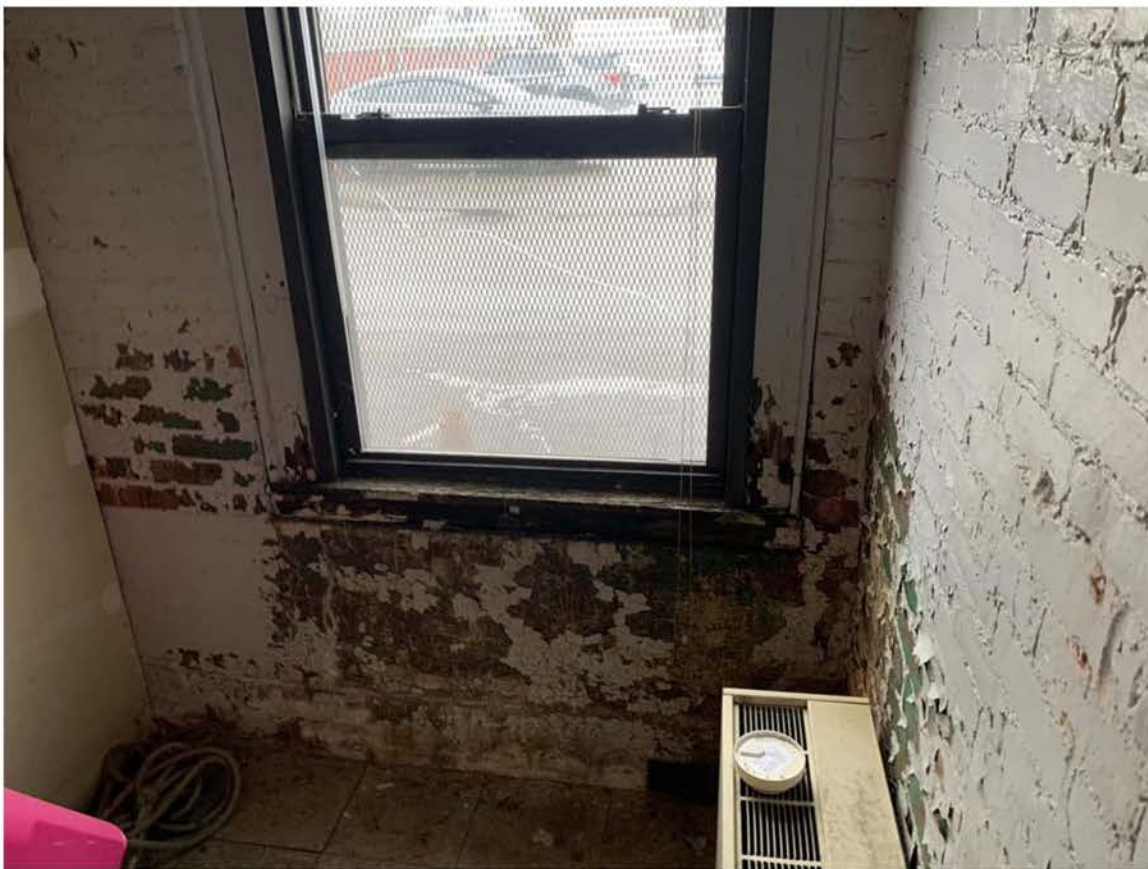
7. There are multiple areas of interior masonry damage due to water infiltration. See "Interior Masonry Water Damage" Photos #11 & #12.
8. At multiple locations, the interior wood headers have water damage and require replacement. See "Interior Wood Header" Photo #13.

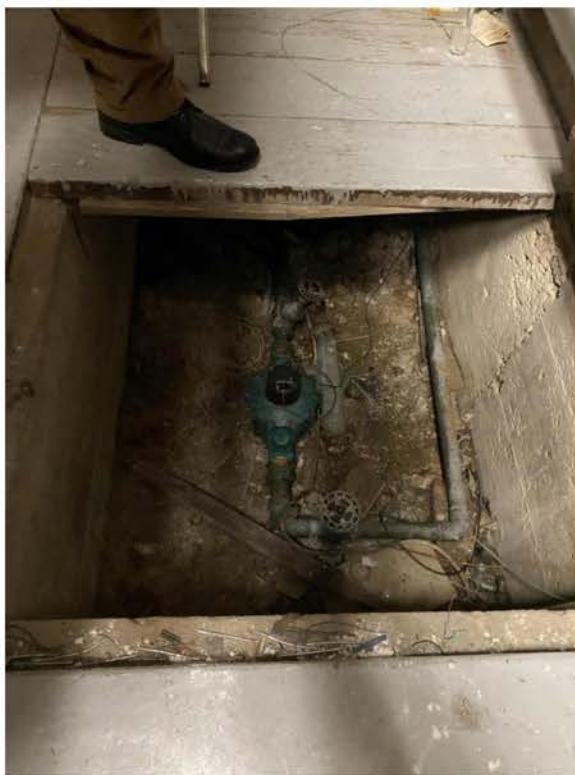
### **P-1 – Water Service**

1. Domestic Water Service: The domestic water service enters the building in the main electrical room, within a pit in the floor. The water service to the building is 1 ½" with no backflow protection or pressure regulator. This service is in working condition but the installation location within the pit makes maintenance a challenge. The size of the service would have to be analyzed based on proposed future renovations to the building and would probably need to be upgraded. There was a domestic water well noticed on site along with a domestic water storage tank located within the building. However the tank was empty and CES was advised that it is no longer used and the building is entirely feed from the municipal water system. **(Appendix: P-1 & P-2)**

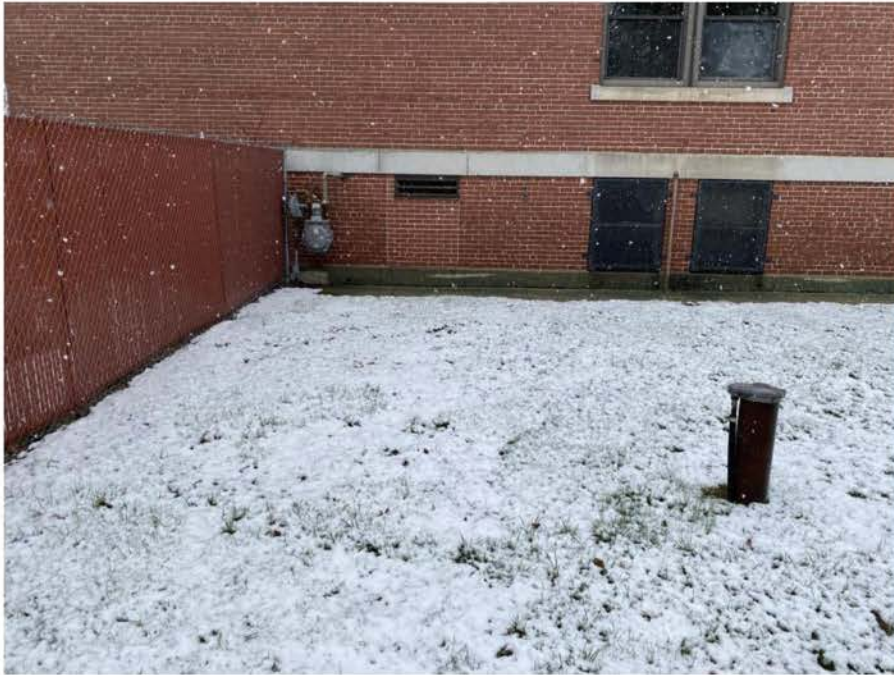
### P-3 – Natural Gas Service

3. Natural Gas Service: The natural gas service assembly is located outside of the building on the southeast side, where it then enters the building. Natural gas piping was observed to be steel with welded and threaded joints. The gas piping is ¾" to the meter and 1 ½" to the entire building. The gas piping appears to be in working condition, but at the end of its useful life. The gas piping would need to be replaced within the entire building if the building were to be renovated. **(Appendix: P-3)**

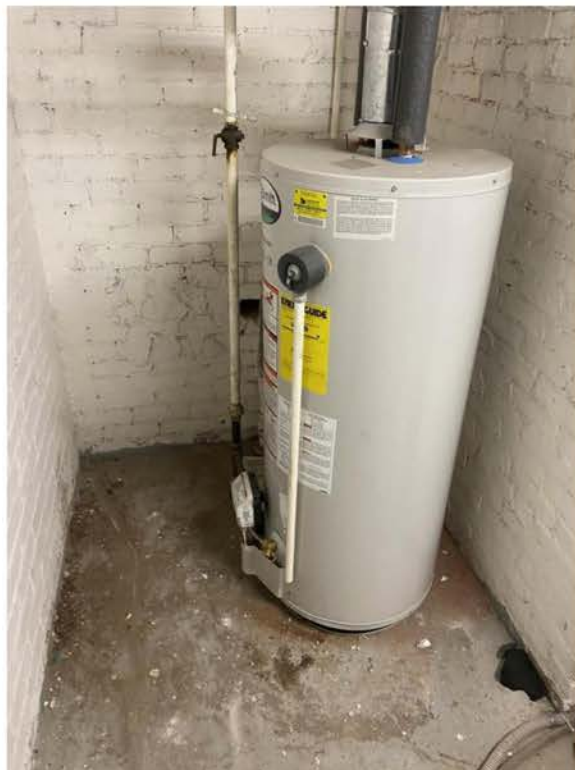
### P-4 Domestic Hot Water

5. Domestic Hot Water System: Domestic water is currently generated by a single gas fired Water Heater. The heater is manufactured by AO Smith and is a 40 Gallon Tank with an input of 40,000 BTUH. This water heater was installed in 2013 and is in good working condition. While the water heater is in good condition, there is only one water heater in the facility. If the heater were to go down for maintenance or need repairs there would be no hot water in the building. It was also observed that there was not a mixing valve on the discharge of the water heater to regulate the building temperature and there was not a recirculation pump. The hot water plant would need to be expanded or replaced in its entirety if the building were to be renovated. **(Appendix: P-4)**

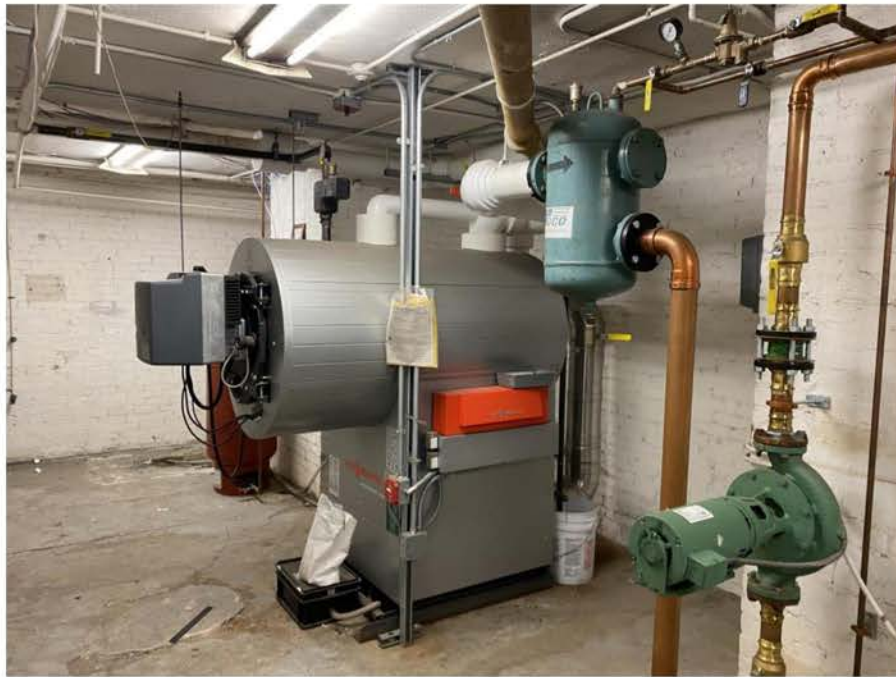
### **M-1 – Boiler Plant**

1. The existing boiler plant consists of one (1) boiler. This boiler feed the entire building and is a natural gas Viessmann boiler rated at 638,000 BTUH input. This boiler has a manufacturer date of 2010, which would make it approximately 10 years old. It appears that the boiler, expansion tank, air separator and boiler room piping wall were all installed at this time. While this system is in good working condition the plant only consists of one boiler and therefore provides no redundancy to this plant. If the boiler was to go down for maintenance or need repairs the building would be left without heat (**Appendix: M-1 & M-2**). The boiler plant would need to be expanded or replaced if the building were to be renovated.

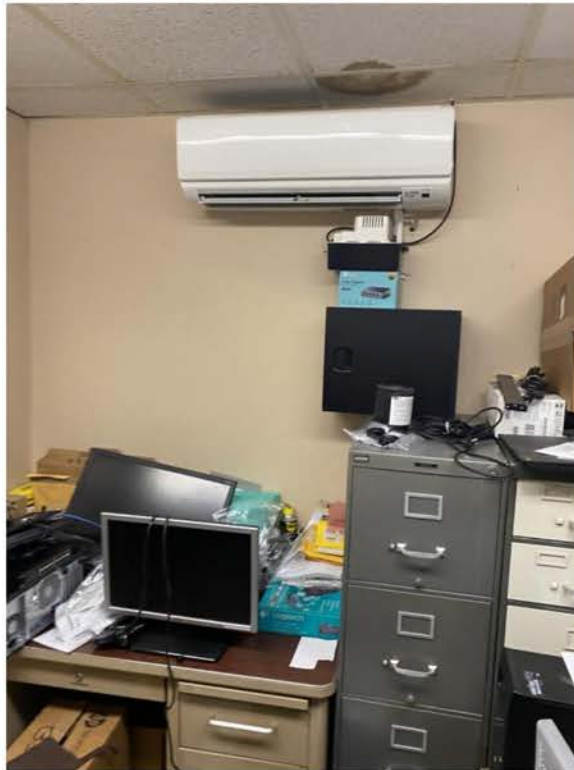
**M-4 – Ductless Split Air Conditioner**

3. Air Conditioning is only provided within the old town hall side of the facility. This is achieved through the use of four (4) packed rooftop units. These units feed ductwork, which serve the office spaces in the old town hall side. The police department side of the building does not contain any permanent air conditioning. Air conditioning for these offices is provided by window air conditioning units. Air Conditioning is also provided in the Communications Equipment room by the use of two ductless split unit. (**Appendix: M-4**) These units are newer and in good working condition.

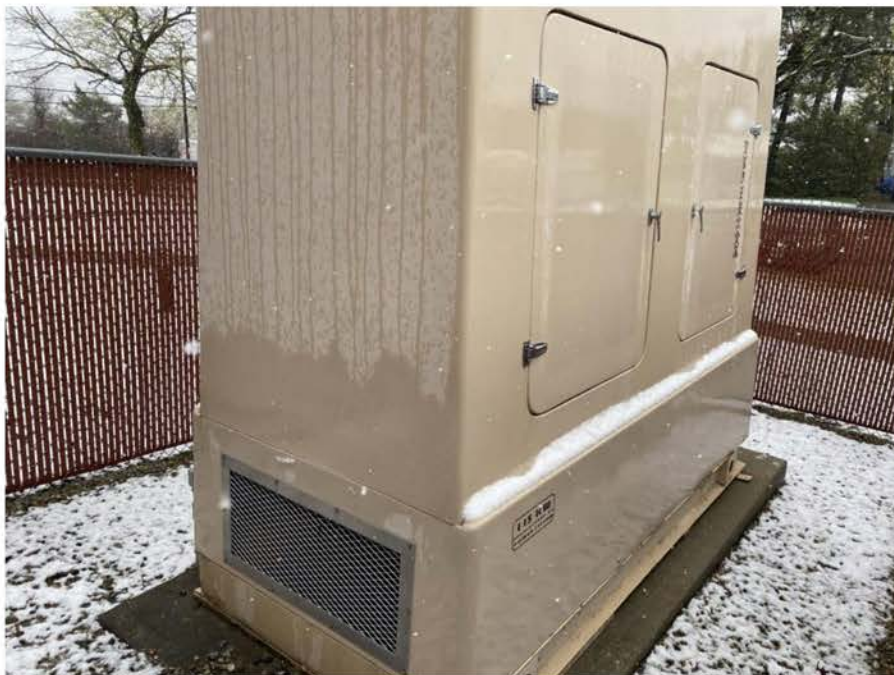
**E-4 – Generator**

1. The building is currently served by an onsite diesel generator. The generator is manufactured by Superior and rated for 115 KW. This generator serves as backup for major components in the building including emergency lights, heating plant, fire alarm, IT Power and Police communications. If the building were to be renovated, the generator would need to be replaced and would be sized to back up the entire building. A new generator would also have 72 hours worth of fuel storage for run time to keep the building operational. **(Appendix: E-4)**
