# Standards for Rehabilitation & Guidelines for Rehabilitating Historic Buildings

## Standards for Rehabilitation

### Introduction

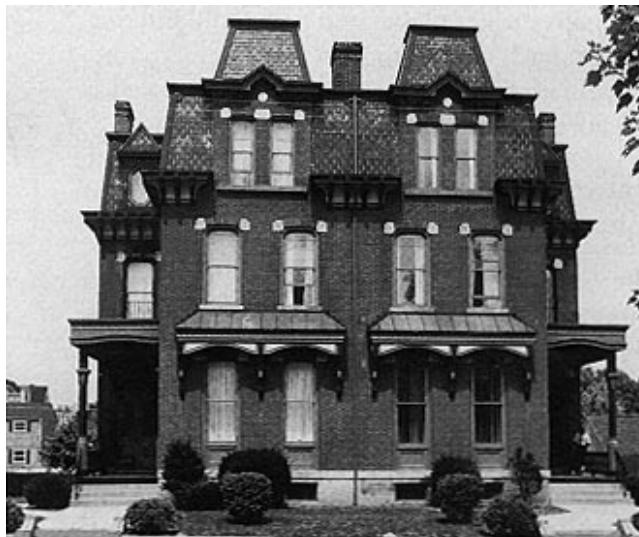
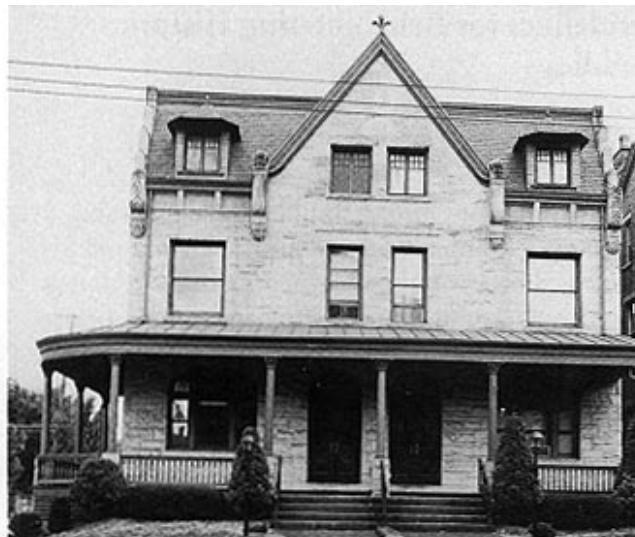
*Originally built as single-family, semi-detached duplexes, these houses were rehabilitated for a new use as rental apartments. While some alteration to non-significant interior features and spaces was necessary in each one, the exteriors were essentially preserved. Photos: Mistick, Inc.*

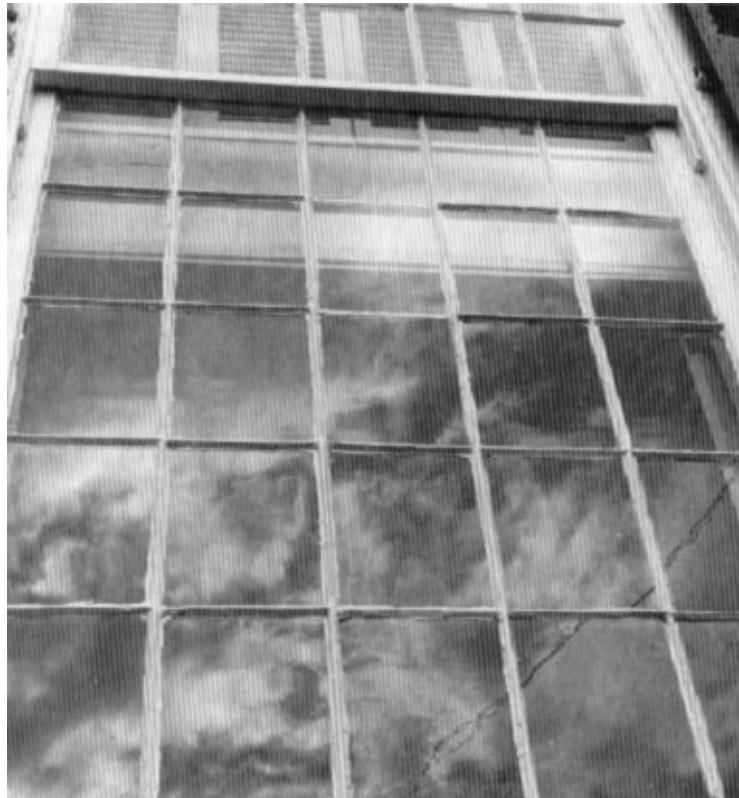
*According to the Standards for Rehabilitation, existing historic materials should be protected, maintained and repaired. In an exemplary project, the windows and shutters of this historic residence were carefully preserved.*

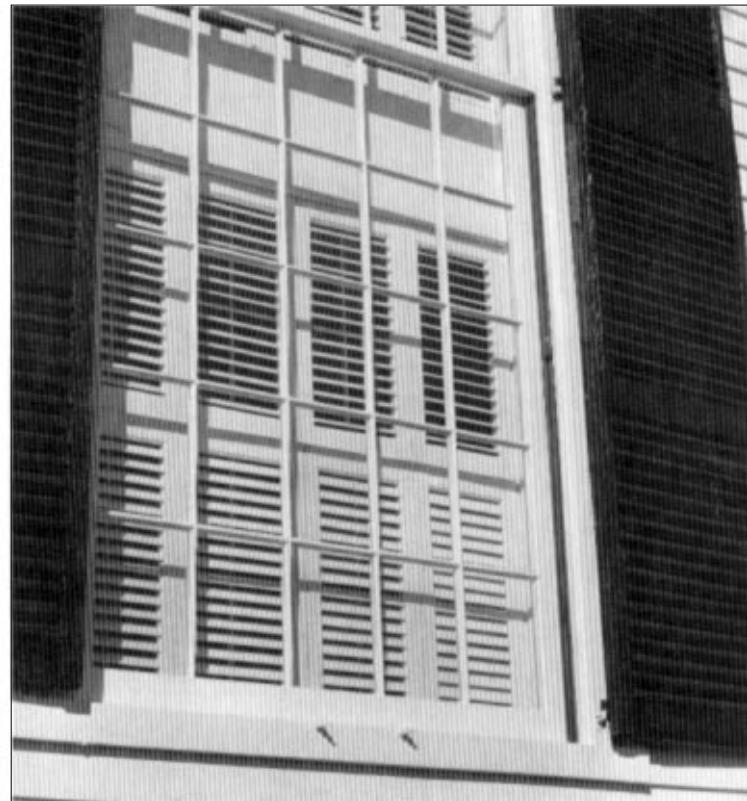
Using destructive paint removal methods such as propane or butane torches, sandblasting or waterblasting. These methods can irreversibly damage historic woodwork.

Using thermal devices improperly so that the historic woodwork is scorched.

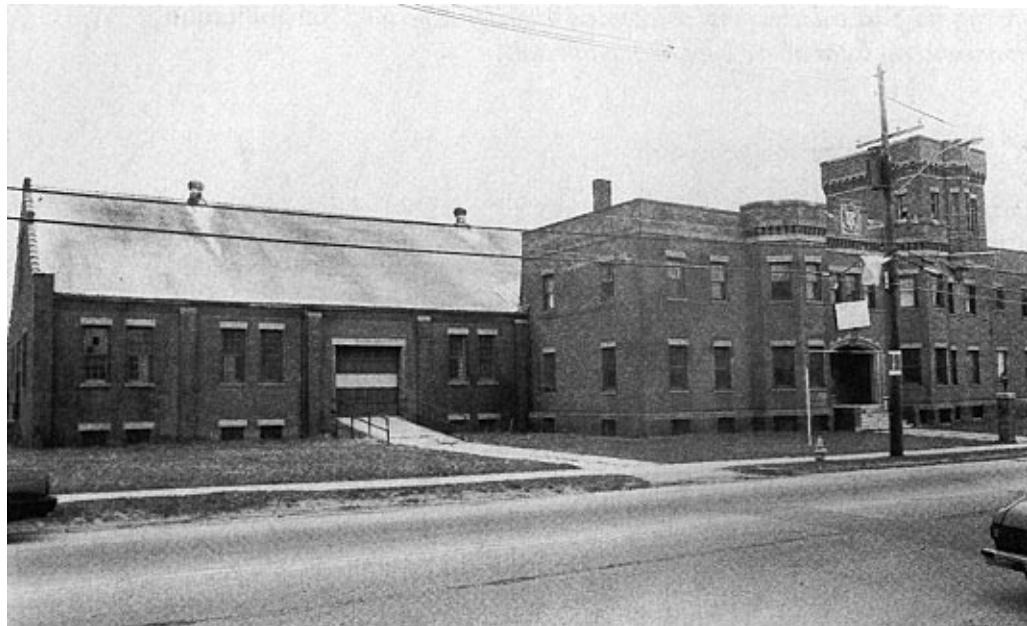
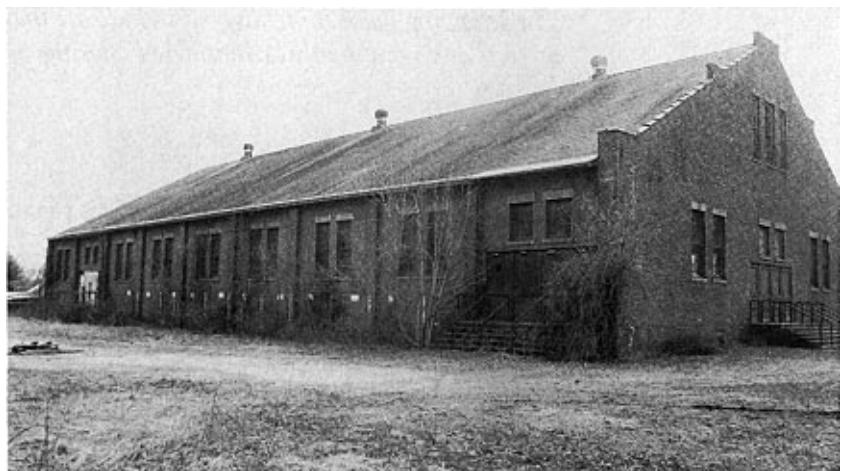
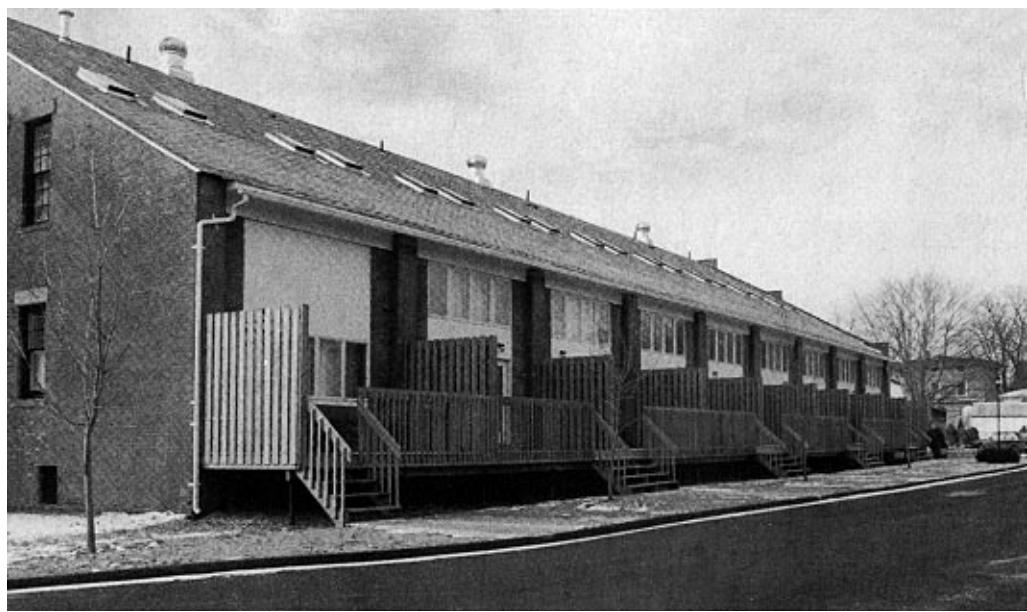
*(a) An armory complex was rehabilitated for rental housing. (b) This view of the rear elevation shows the paired, nine-over-nine wood sash windows and high sills that characterized the building. (c) After inappropriate rehabilitation work, the same rear elevation is shown with new skylights added to the roof, prefabricated panels filling the former brick areas, and new wood decks and privacy fences. Because the work changed the historic character, the project did not meet the Standards.*

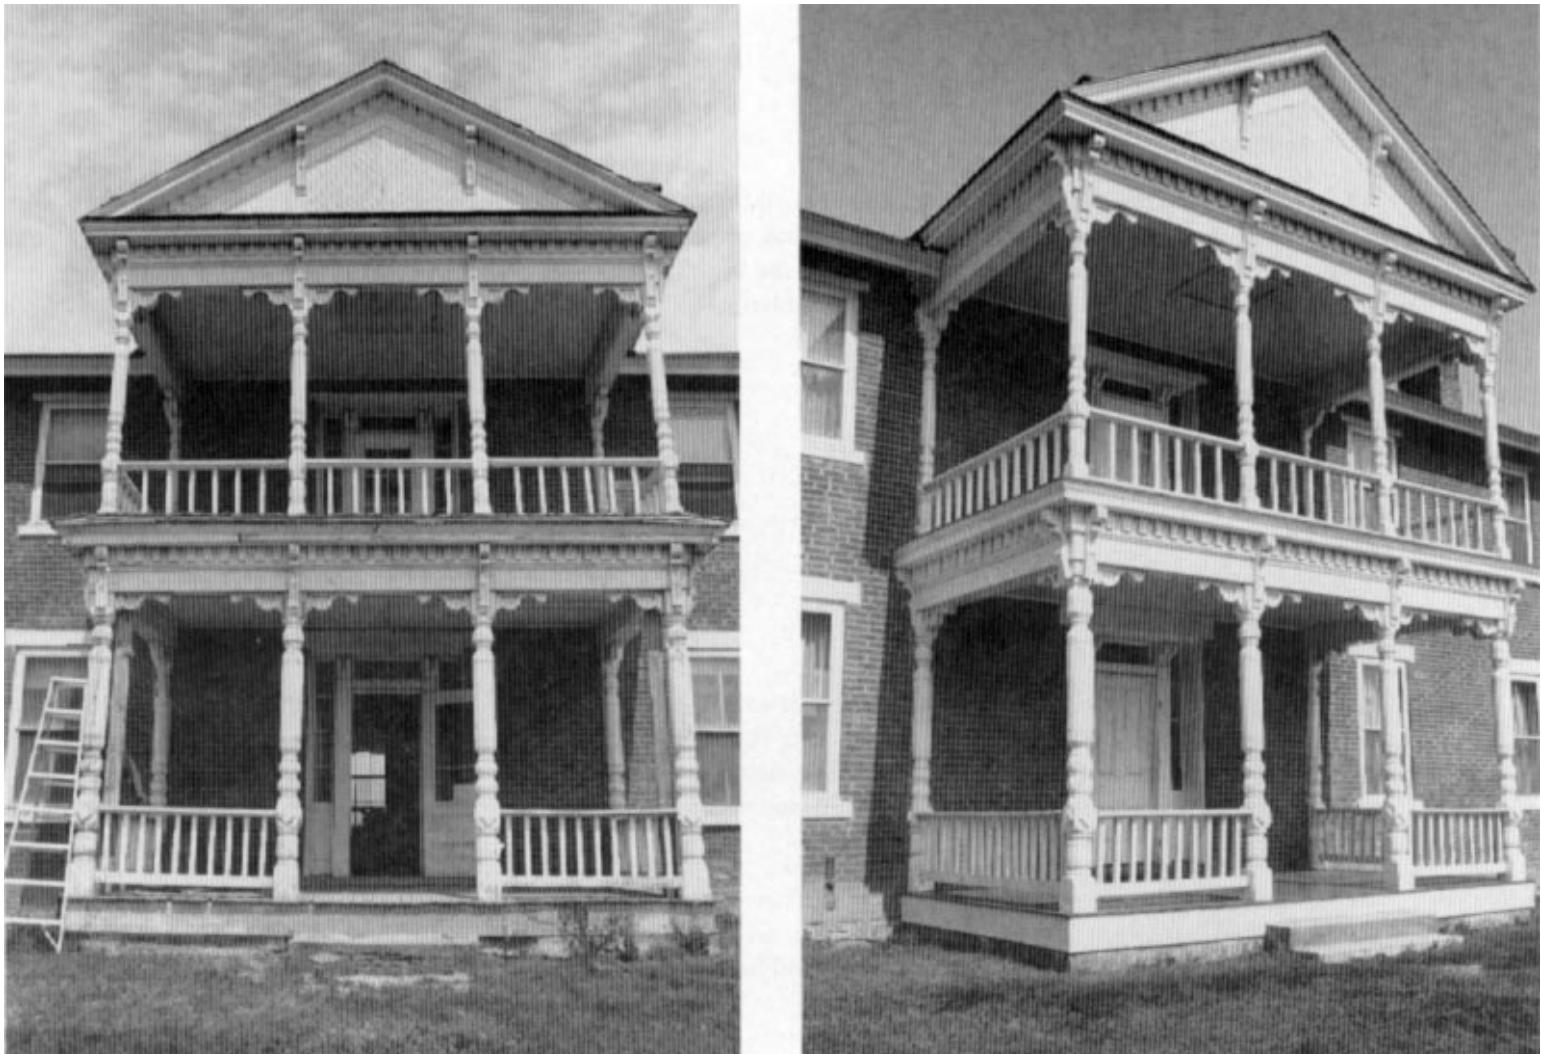
*In Rehabilitation, deteriorated features should be repaired, whenever possible, and replaced when the severity of the damage makes it necessary. Here, a two-story porch is seen prior to treatment (left). The floor boards are rotted out and the columns are in a state of collapse, supported only by crude, temporary shafts. Other components are in varying stages of decay. Appropriate work on the historic porch (right) included repairs to the porch rails; and total replacement of the extensively deteriorated columns and floor boards. Some dismantling of the porch was necessary.*

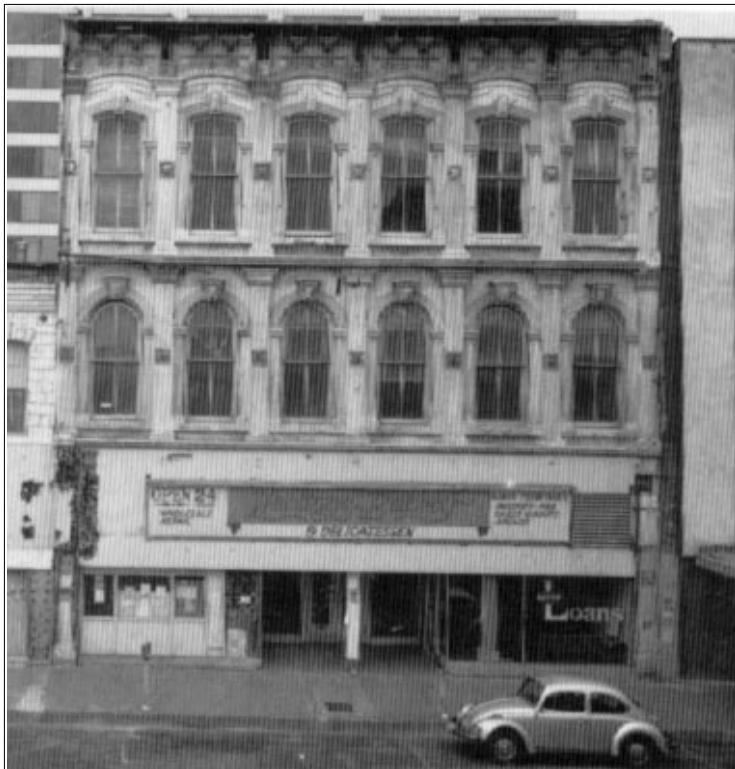
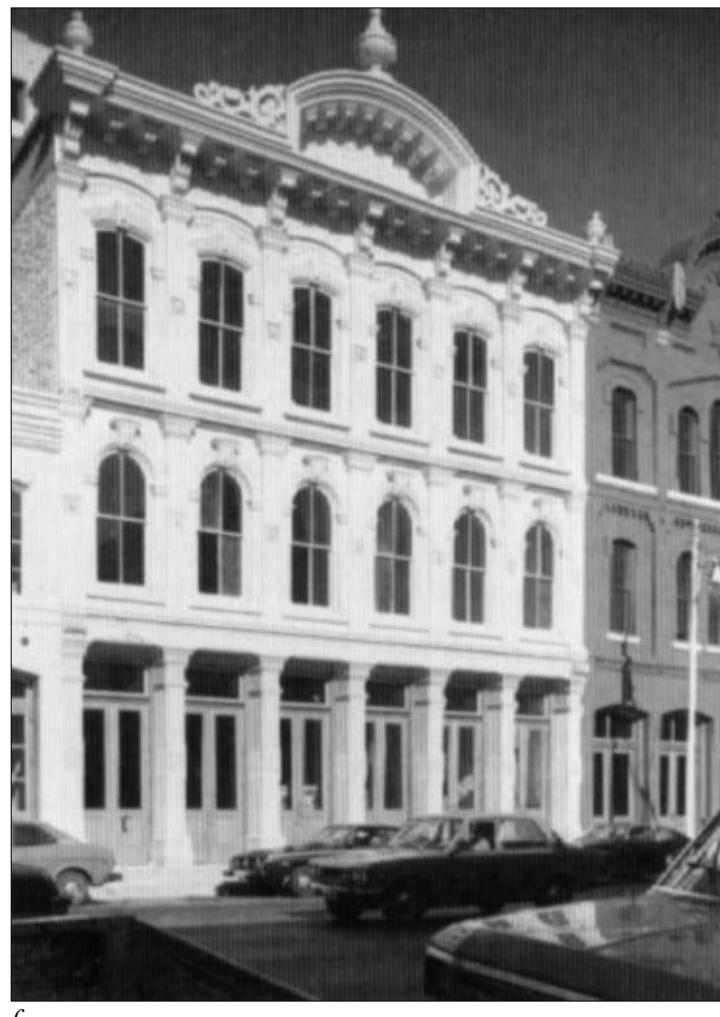
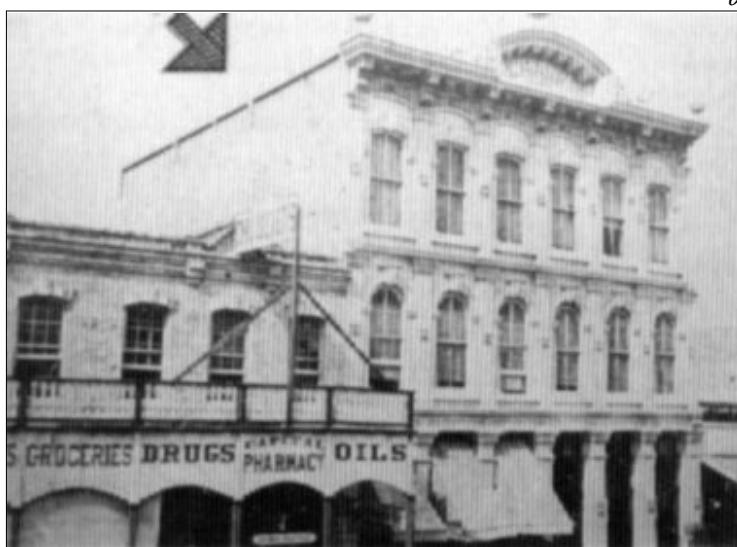
*In the treatment, Rehabilitation, one option for replacing missing historic features is to use pictorial documentation and/or physical evidence to re-create the historic feature. (a) In this example, the ornamental cornice of an 1866 limestone building was missing; and the ground level storefront had been extensively altered. (b) and (c) Based on the availability of photographic and other documentation, the owners were able to accurately restore the cornice and storefront to their historic configuration. A substitute material, fiberglass, was used to fabricate the missing pressed metal cornice, an acceptable alternative in this project. All work met the Standards.*

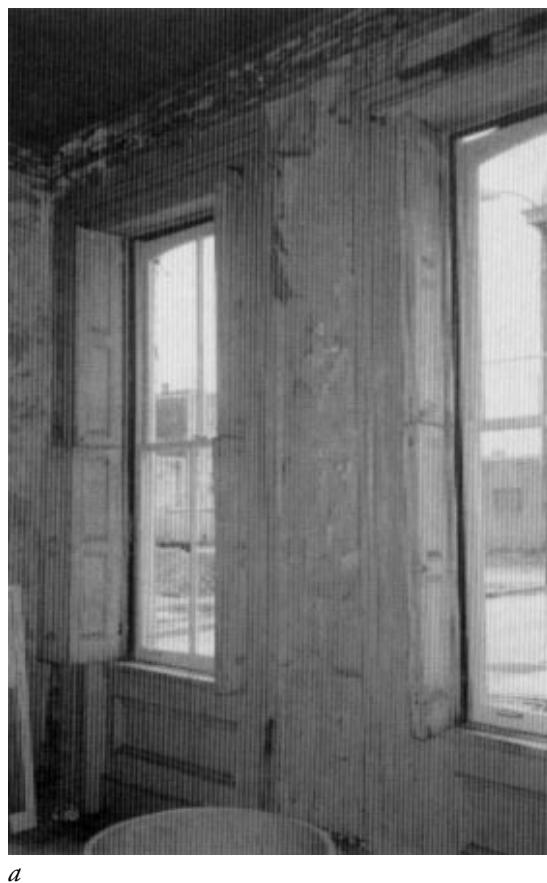
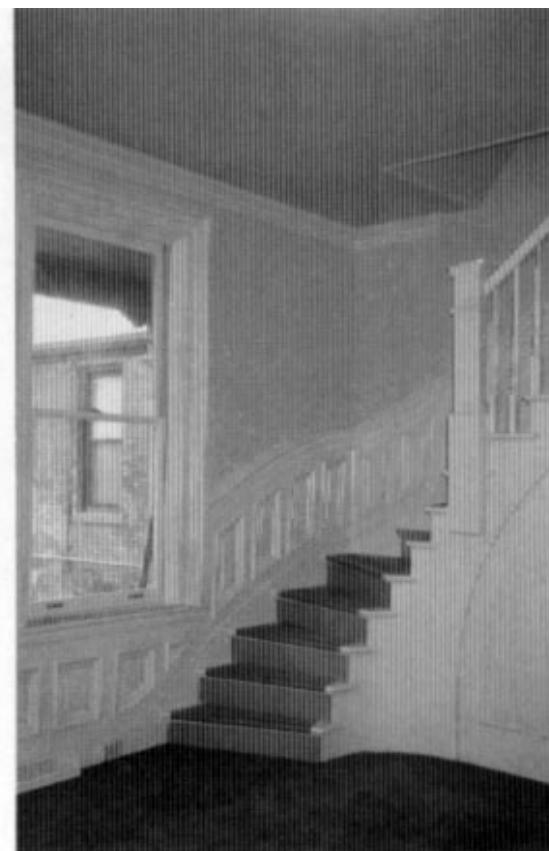
*Rehabilitating historic dwelling units often includes some level of lead-paint hazard abatement. Whenever lead-base paint begins to peel, chip, craze, or otherwise comes loose (a), it should be removed in a manner that protects the worker as well as the immediate environment. In this example (b), the deteriorating lead-paint was removed throughout the apartment building and a compatible primer and finish paint applied.*

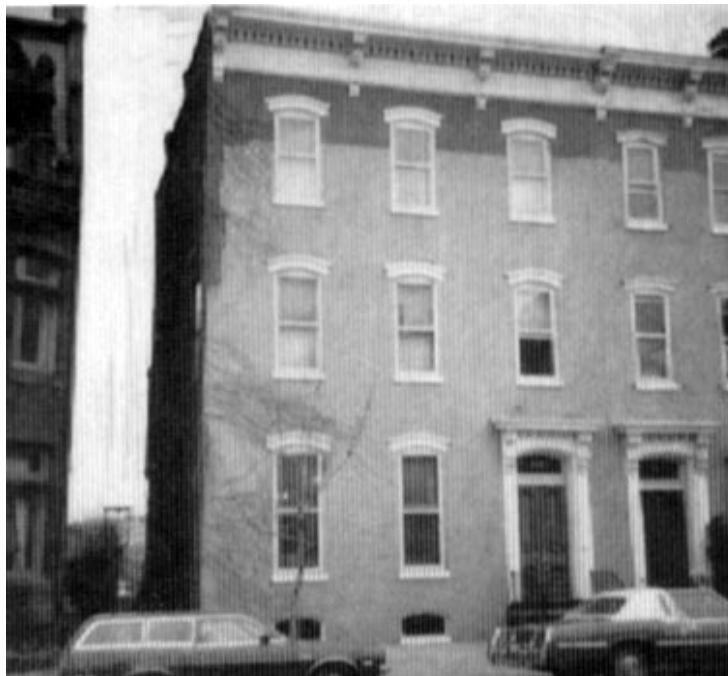
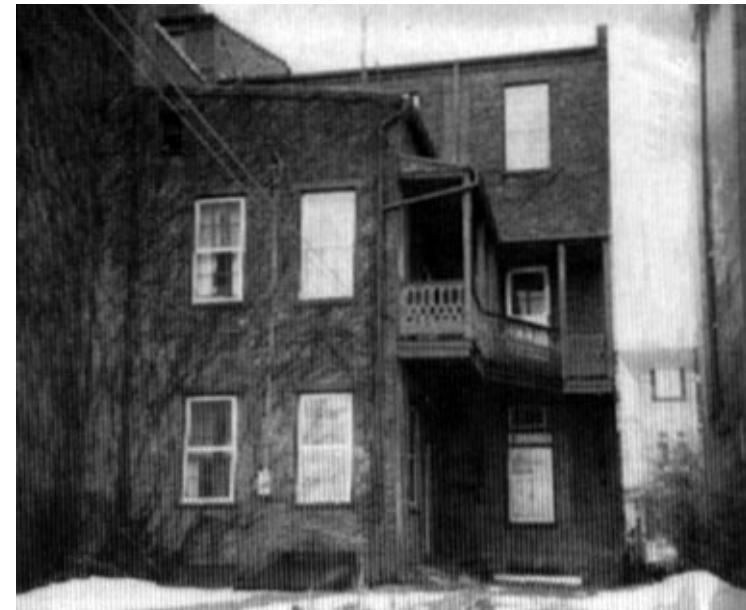
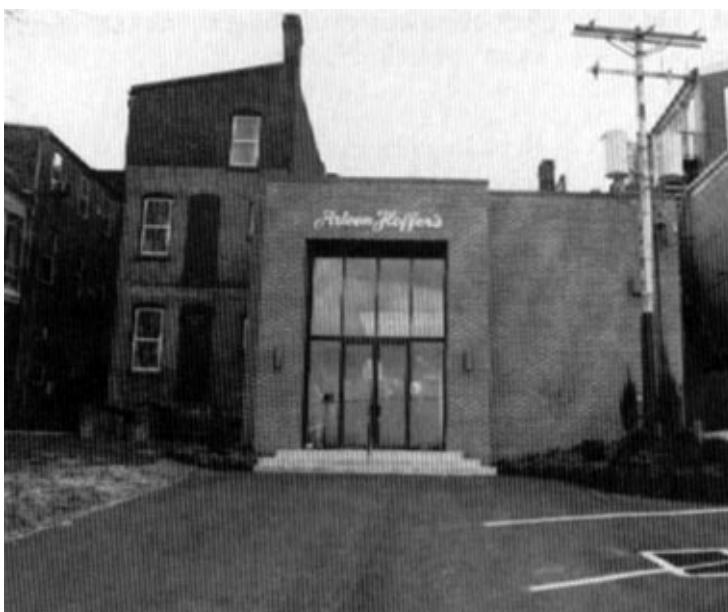
*If a rear elevation of a historic building is distinctive and highly visible in the neighborhood, altering it may not meet the Standards. (a and b) This 3-story brick rowhouse featured a second story gallery and brick kitchen wing characteristic of other residences in the district which backed onto a connecting roadway. (c) In the rehabilitation, the wing and gallery were demolished and a large addition constructed that severely impacted the building's historic form and character.*

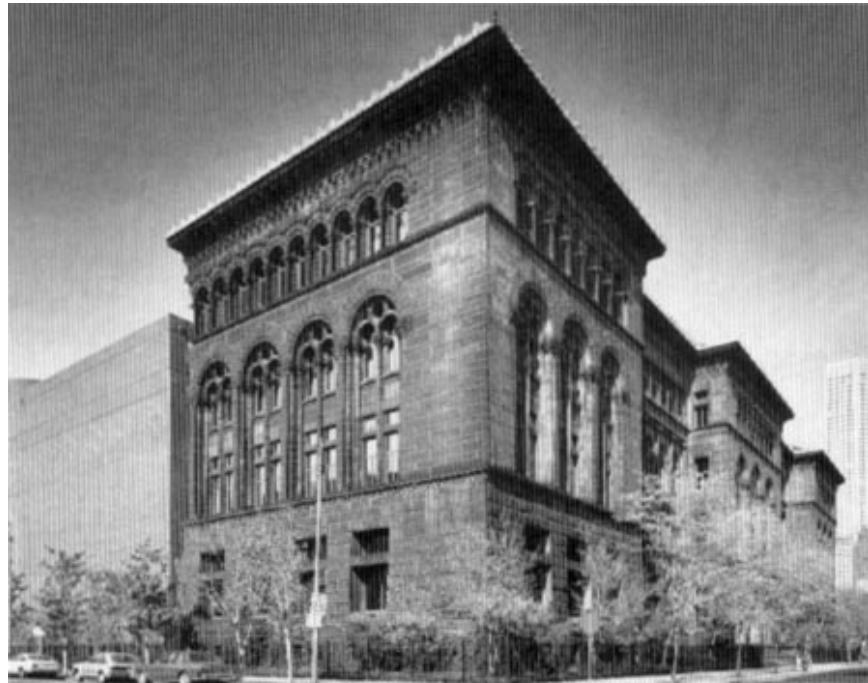
*Rehabilitation, like Preservation, acknowledges a building's change over time; the retention and repair of existing historic materials and features is thus always recommended. However, unlike Preservation, the dual goal of Rehabilitation is to—respectfully—add to or alter a building in order to meet new use requirements. This downtown Chicago library was expanded in 1981 when additional space was required with light and humidity control for the rare book collection. The compatible 10-story wing was linked to the historic block on side and rear elevations. Its simple design is compatible with the historic form, features, and detailing; old and new are clearly differentiated.*  
*Photo: Dave Clifton.*
