# POLICE DEPARTMENT RENOVATION OR REPLACEMENT ANALYSIS

TOWN OF NORTH SMITHFIELD, RHODE ISLAND

SEPTEMBER 2021

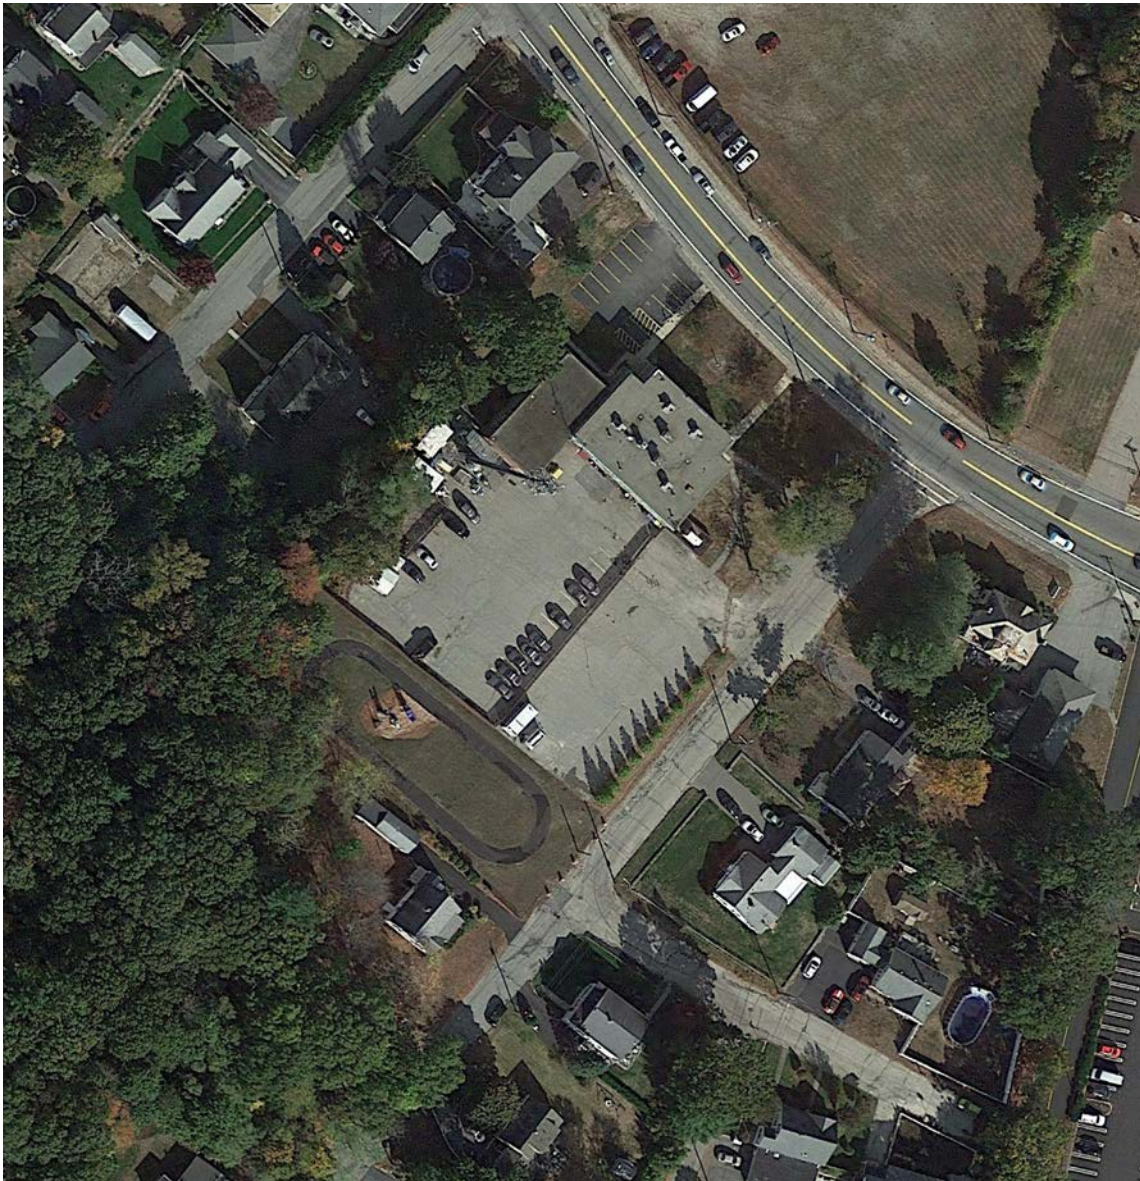
Site Aerial View

The site does not offer a sufficient, secure area for the department to store vehicles that need to be protected as evidence, nor does it afford a concealed location for unmarked cruisers. Additionally, there is no covered parking to protect fleet vehicles. Site circulation is a significant issue, having only one point of access on and off site from Merrimac Road, and no clear path to the main building entry. Current public

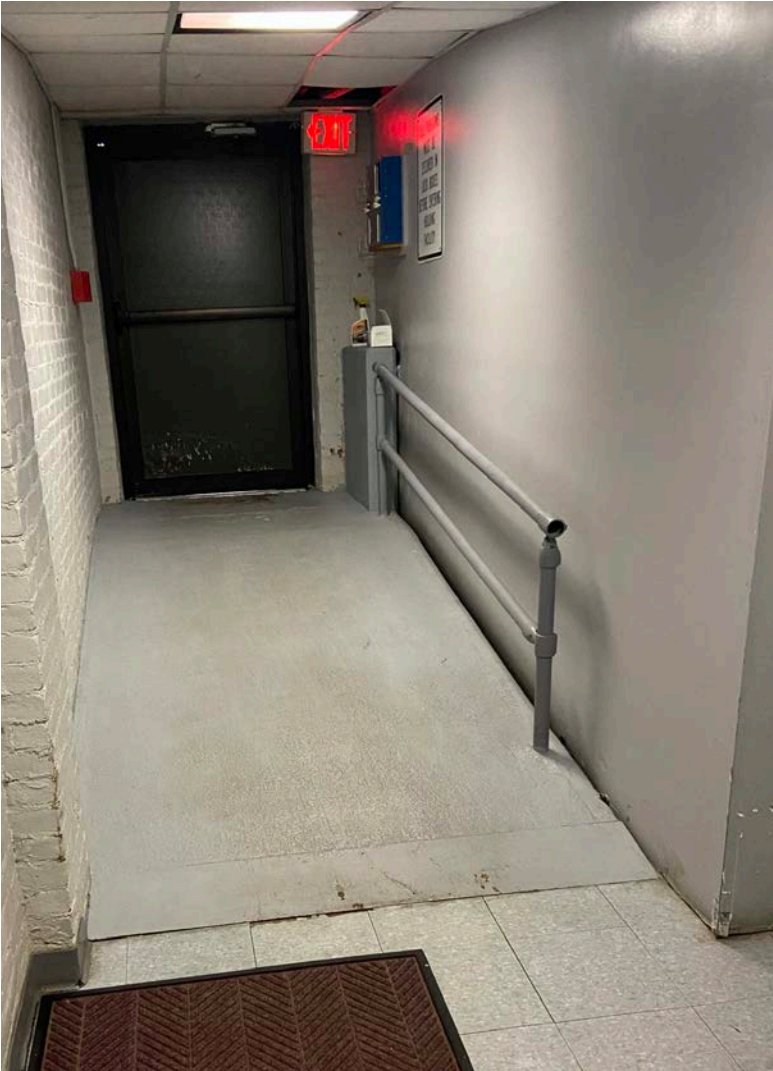
Ramp to Detention Facility

The route for prisoner intake is unsafe. When entering the building, officers must escort prisoners down a ramp. This poses a safety concern. There is no sally port or secure area for processing, which put the officers at risk when taking prisoners out of a cruiser and into the building. Since there is no sally port, officers cannot leave prisoners in the cruiser and secure their weapon in the pistol locker prior to bringing the prisoner in the door. Instead, they must secure their weapon just after entering the building with the prisoner. There is no sight/sound separation in the detention area. Prisoners being taken to the juvenile/female detention facility are escorted past the male and female staff locker rooms. The juvenile cell is located immediately off a main corridor. Wire mesh partitions at this location are not ligature resistant, the in-swinging door can be barricaded, and prisoners can get underneath the furniture and use it for self-harm. Ceilings are too low in the cell area. It is recommended that these ceilings be at least 10'-0" high to prevent a detainee from accessing or damaging the ceiling, light fixtures, and cameras. The cells themselves are very small and do not meet the current standards for preventing self-harm. Cell walls are painted CMU and are in good condition, however a plumbing access panel inside the cell poses an additional security concern. Male cell doors have bars with horizontal members making them not ligature-proof, but they are at least out-swinging doors. The bunk and the toilet as well, could be used for self-harm. These spaces should release into a public area outside, and away from the secured cruisers. Should a large renovation be undertaken, the prisoner processing and detention areas would require a complete remodel in order to meet current code, public safety standards, and accreditation requirements.

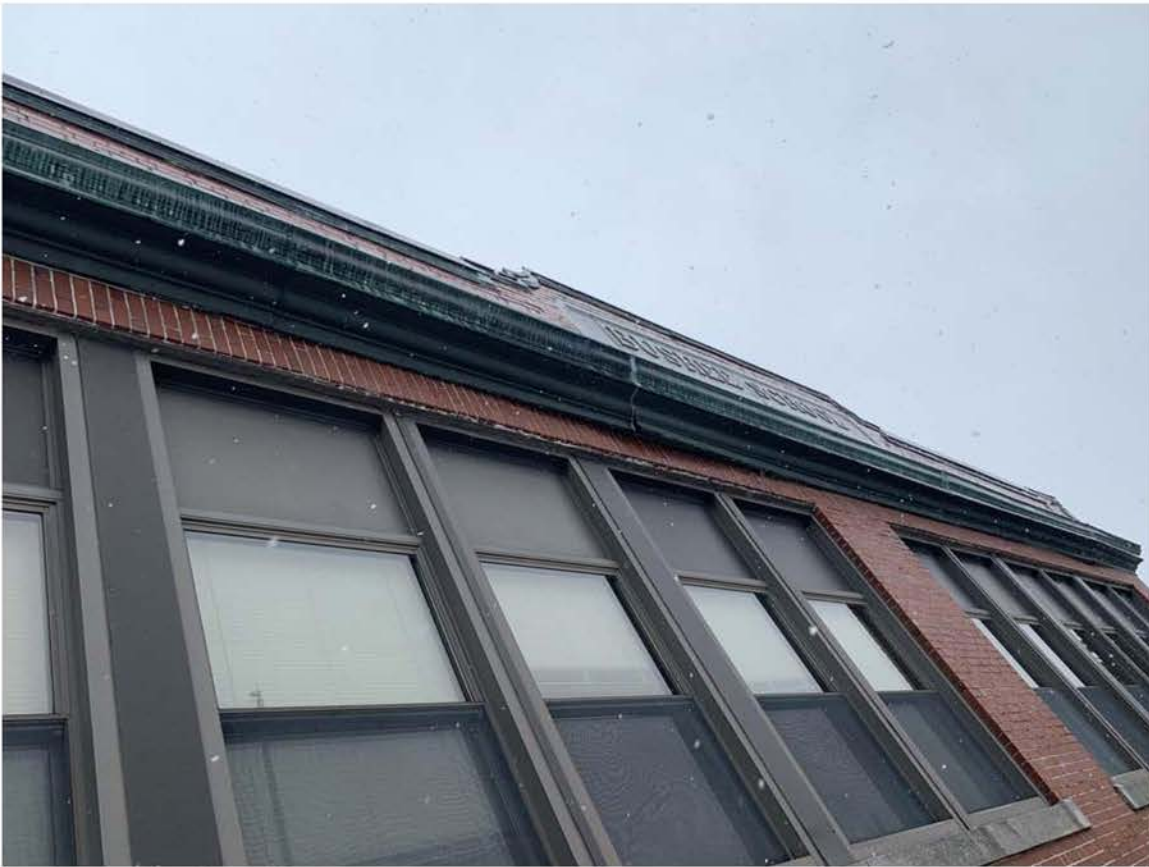
Front Parapet Photo #1

1. The front parapet wall is in danger of falling off the building and the area below should be off limits. See "Front Parapet" Photos #1 & #2.
2. The majority of the existing roof parapet needs to be removed or removed and completely rebuilt. See "Parapet" Photo #3.

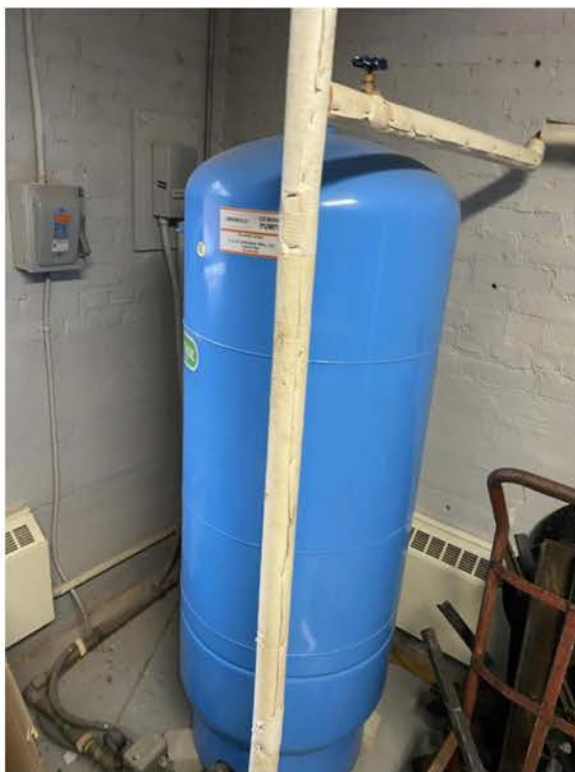
### **P-2 – Abandoned Well Tank (Well Outside of Building)**

1. Domestic Water Service: The domestic water service enters the building in the main electrical room, within a pit in the floor. The water service to the building is 1 ½" with no backflow protection or pressure regulator. This service is in working condition but the installation location within the pit makes maintenance a challenge. The size of the service would have to be analyzed based on proposed future renovations to the building and would probably need to be upgraded. There was a domestic water well noticed on site along with a domestic water storage tank located within the building. However the tank was empty and CES was advised that it is no longer used and the building is entirely feed from the municipal water system. **(Appendix: P-1 & P-2)**
